Date: December 10, 2014
To: Bruce D. Glasscock, City Manager
From: Amy Fortenberry, Director of Parks & Recreation
Subject: Collinwood House

Re: Collinwood House, Windhaven Parkway at Willow Bend Drive
Plano, TX
JQ Project No. 3140168

Jaster-Quintanilla (JQ) performed a limited, structural review of the Collinwood House on June 24, 2014. The purpose of the review was to assess the structural condition of the original house for the purpose of providing recommendations for repair necessary to make it marketable to sale and capable of being moved. Additions to the house were not included in the assessment.

Re: Physical Inventory of the historic Collinwood House
5400 Windhaven Parkway, Plano, Texas

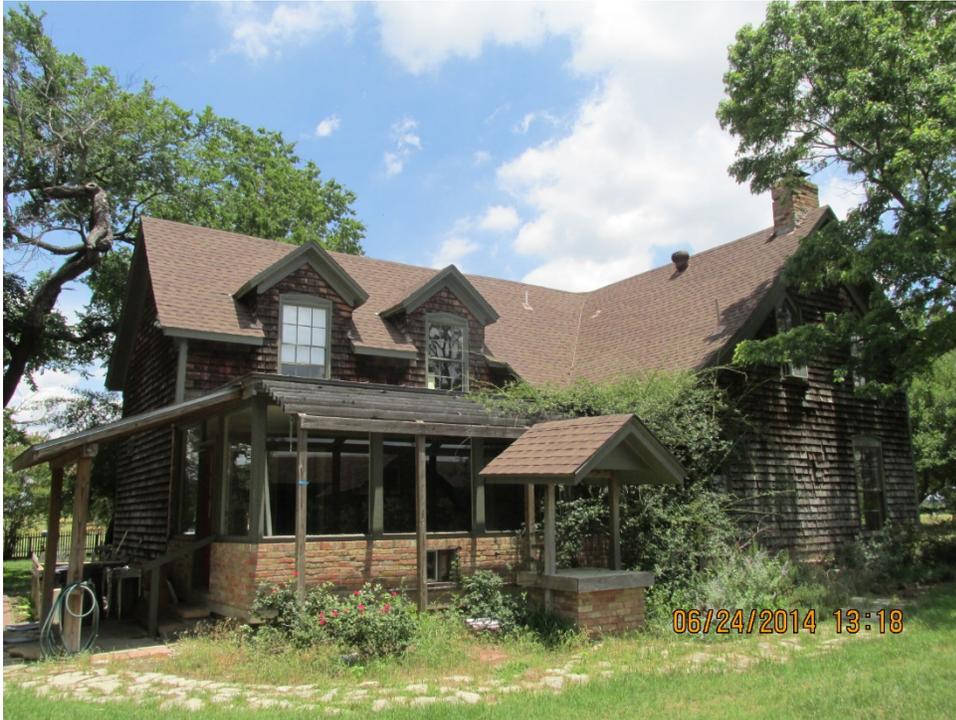
Photograph 1 – Collinwood House

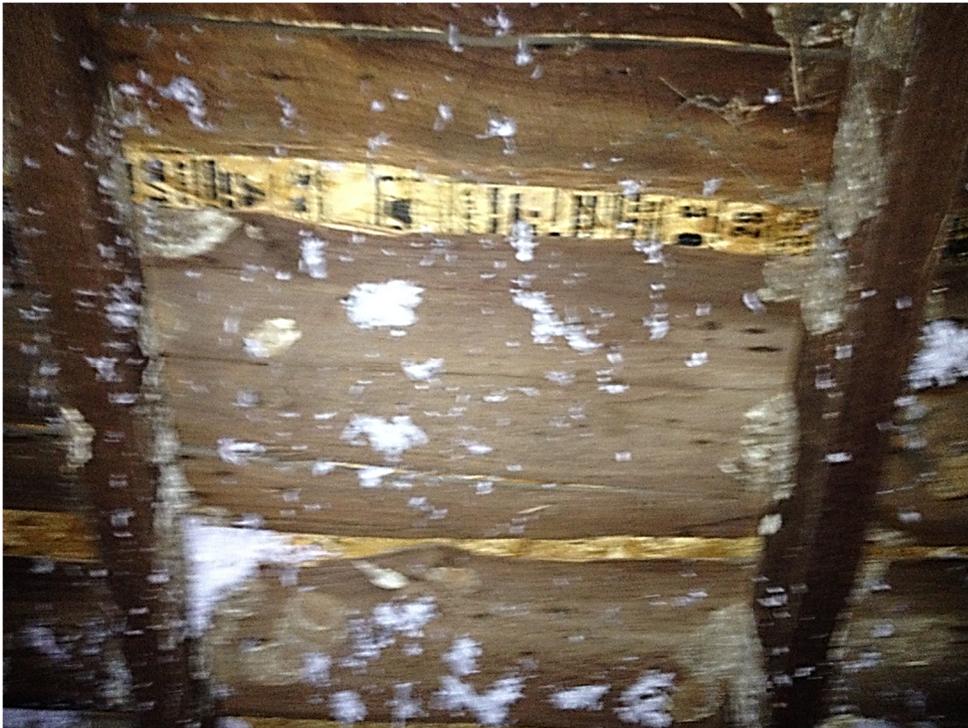
In the attic opening above the kitchen, wood batten strips were observed over timber rafters. The batten strips vary in size, and are spaced irregularly with gaps between the battens. This configuration was common with wood shingles, and is consistent with the construction date of the eastern portion. A more recent plywood deck has been installed over the original batten strips for the asphalt shingle roof. From the access opening no signs of deterioration or distress were observed in the structural framing. The roof structure appeared to be continuous between the eastern portion of the house and the kitchen section (See Photographs 2 and 3).

Photograph 2 – Batten strips in attic above the kitchen.

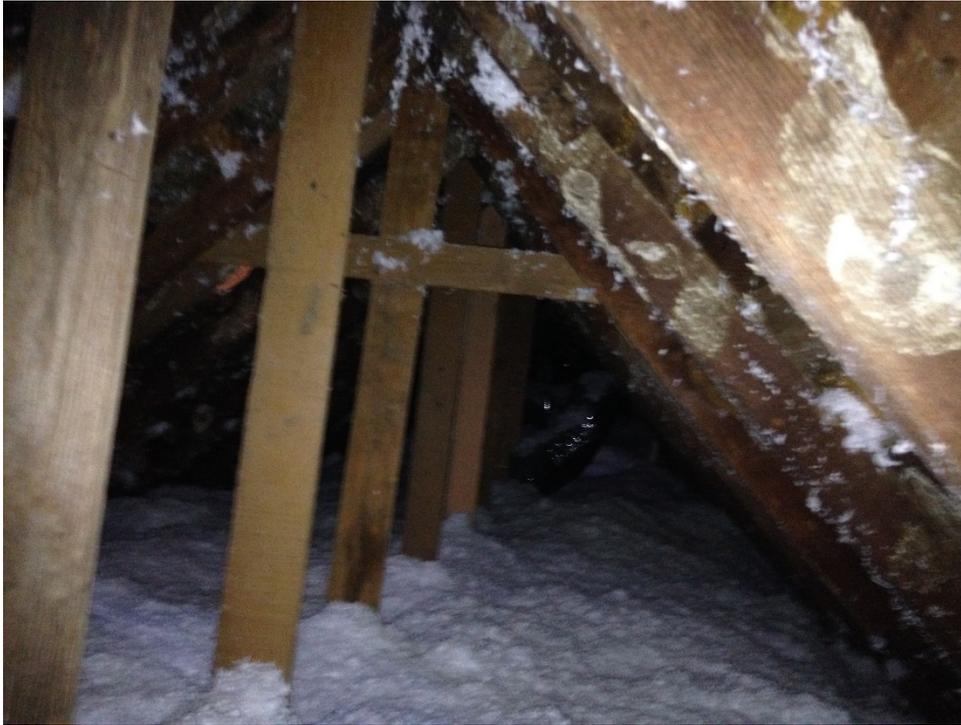
Photograph 3 – Roof framing continuous. Looking into eastern portion from attic access.

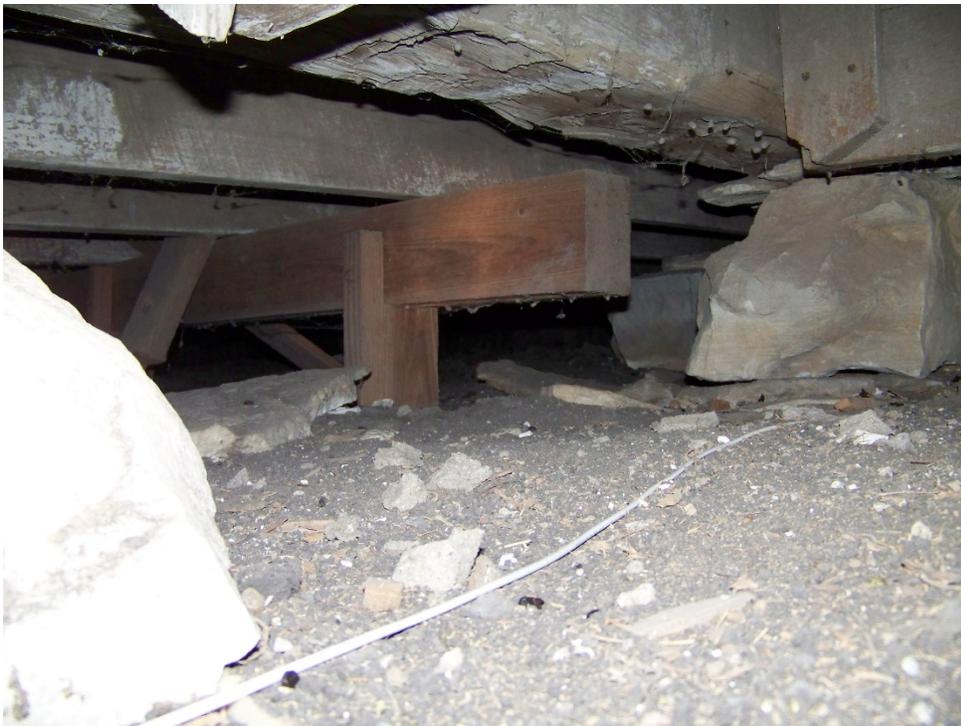
observed. Some of these foundation elements may have been added to address excessive floor deflection, damage to the original foundations, or loss of structural capacity of the floor structure. Excessive deflection or damage to the floor structure was not observed indicating failure or deficiencies in the foundations as installed. (See Photographs 4 and 5).

Photograph 4 – Timber framing and boulders supporting ground floor structure.

- Remove the concrete wall around the perimeter of the house to gain full access to the crawlspace. Repair any deteriorated or damaged floor joists, beams, or connections prior to relocation. Document locations of interior foundation support locations as installed to aid in design of final foundation once the structure has been moved.
- Remove the shingles and siding as necessary to expose the limits of deterioration to the load bearing wall on the north side of the kitchen. Repair deteriorated sections of the wall framing.
- Upon completion of the recommended repairs, it is our opinion that the house is structurally sound and can be considered for moving either as one piece or in sections. We recommend a structure moving specialist be contacted for more specific details.

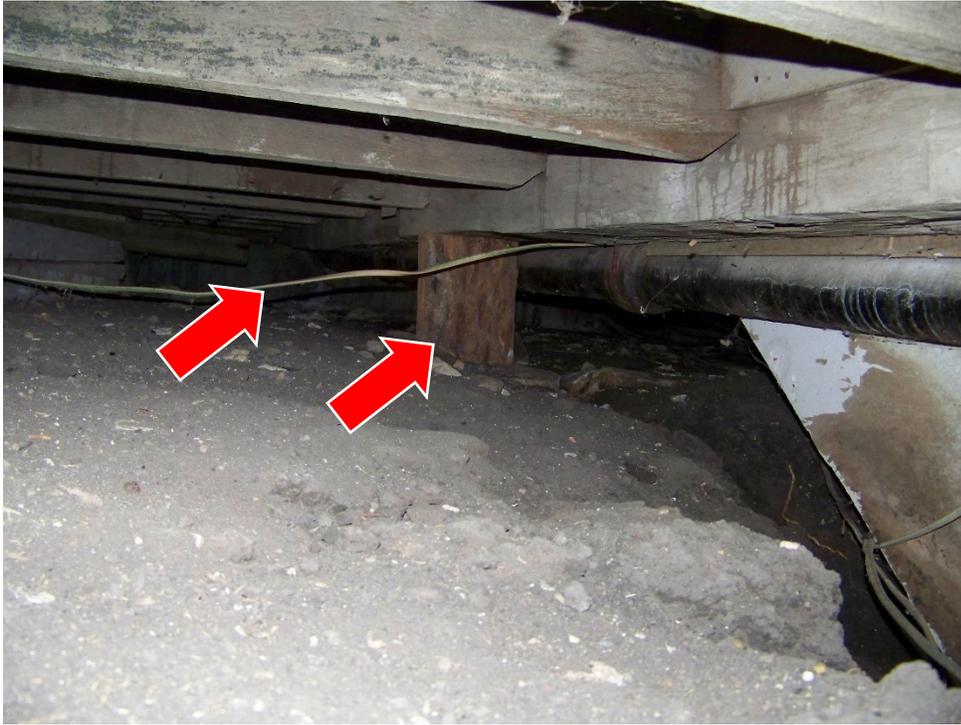
Photograph 5 – Timber pile foundation supporting ground floor structure. Concrete pilaster beyond.

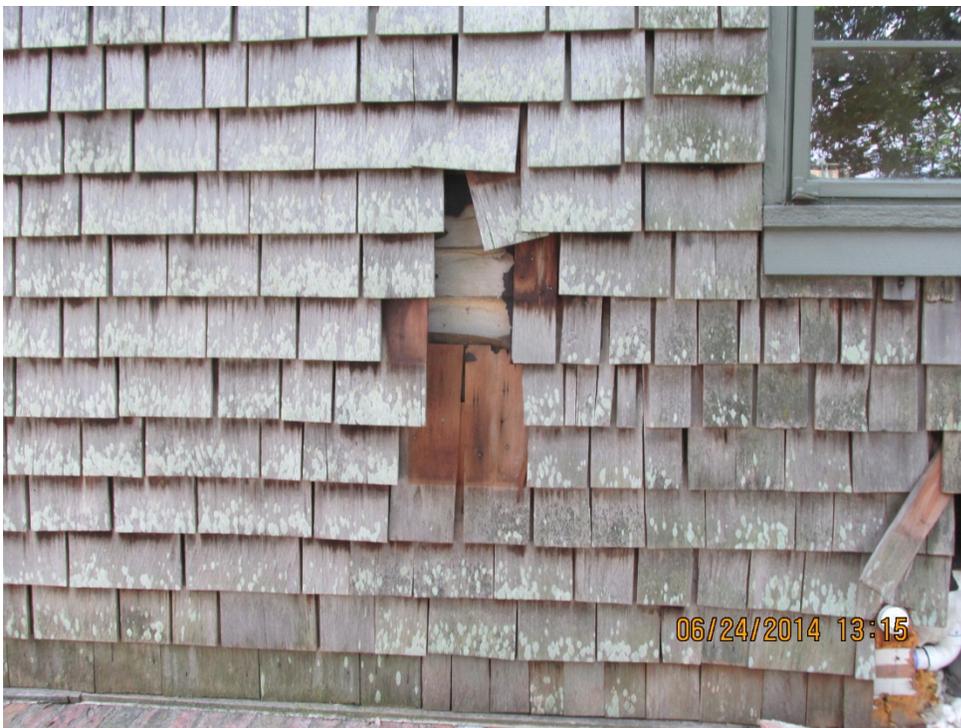
The exterior of the house is clad with cedar shingles. On the north side of the kitchen section, cedar shingles had been removed at two locations. At one location, clapboard siding was observed beneath the cedar shingles. At the second location, siding was not observed behind the shingles. Moderate deterioration of the load bearing wall was observed (See Photographs 6 and 7).

Photograph 6 – Clapboard siding beneath cedar shingles.

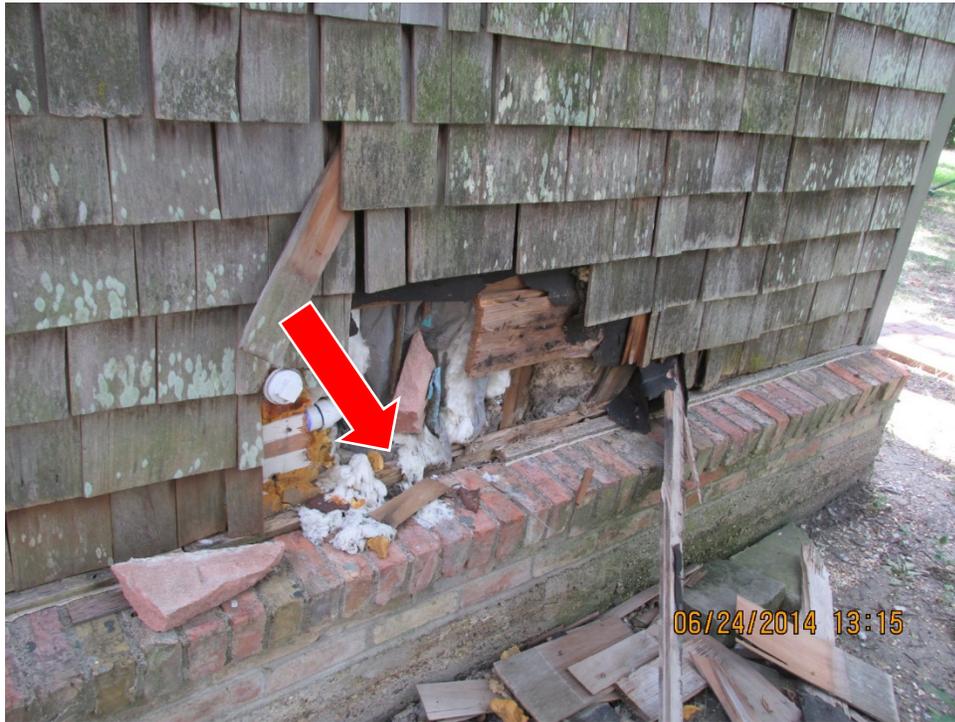
Photograph 7 – Moderate deterioration of load bearing wall timber framing.

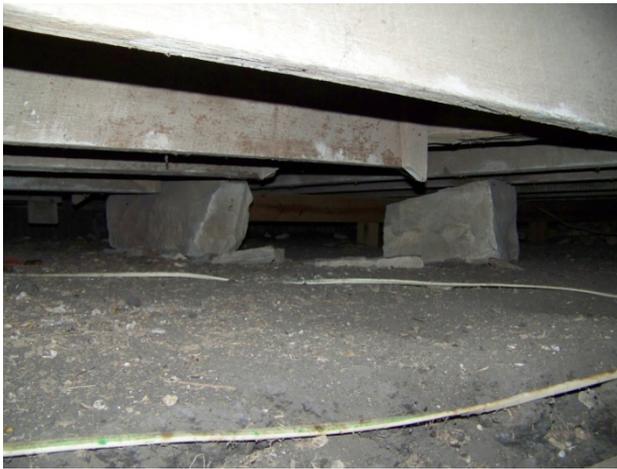
Photo of crawl space below the original house, with stone boulders. Wood bracing of the floor joists are visible in the background.

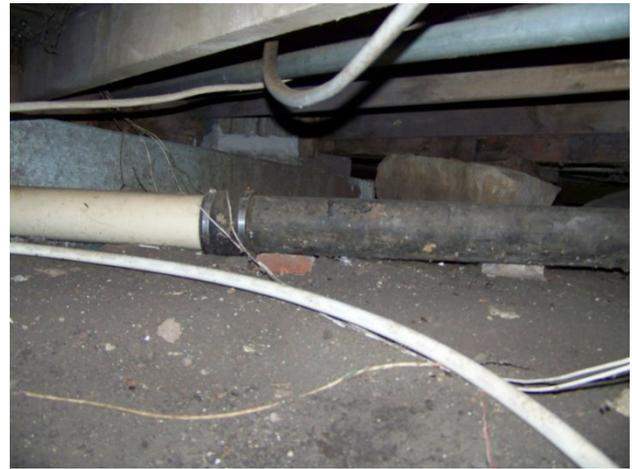
Photo of crawl space below rear wing showing metal, ducts, PVC and metal sanitary line and stone boulders.

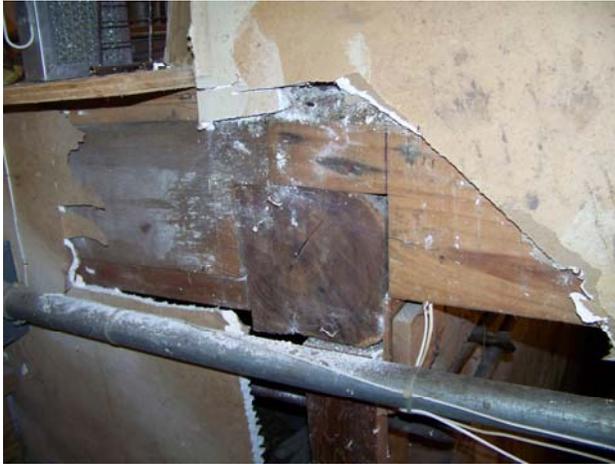
View of perimeter hand-hewn wood beam at east wing; this beam was cut to accommodate stairs.

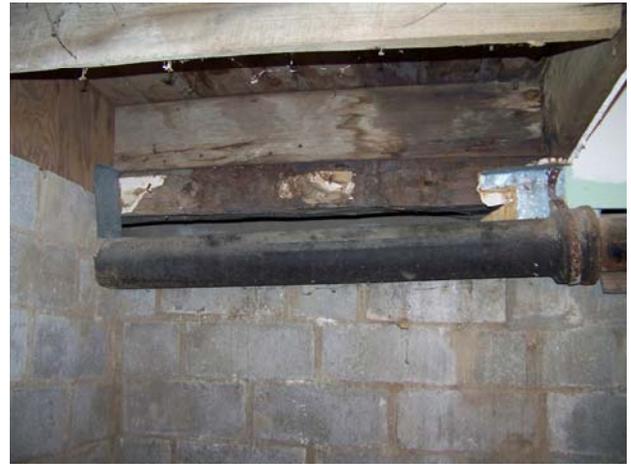
View of concrete block wall in Basement and hand-hewn wood beam w/ steel sanitary sewer below.

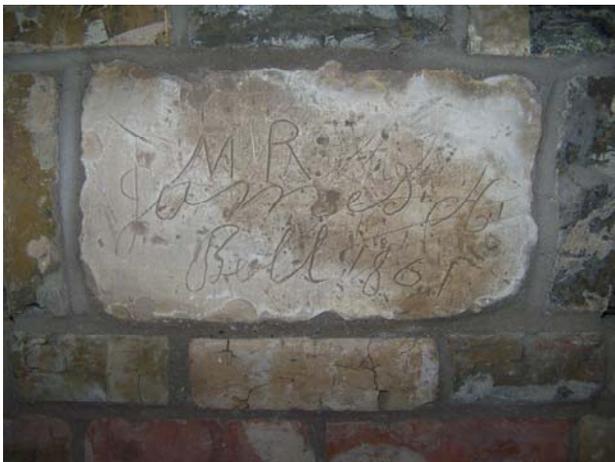
Limestone block with 'Mr. James Bell' and '1861' carved into surface.
